Manhole Inspection Summary

Manhole # S13KK1008MH

Location Address: **4500 WYLIE AVE**

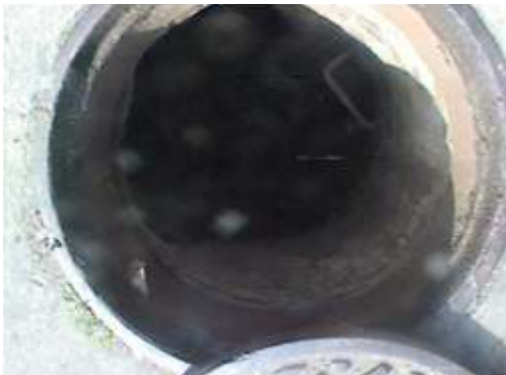
Top View

DEBRIS ON CHANNEL

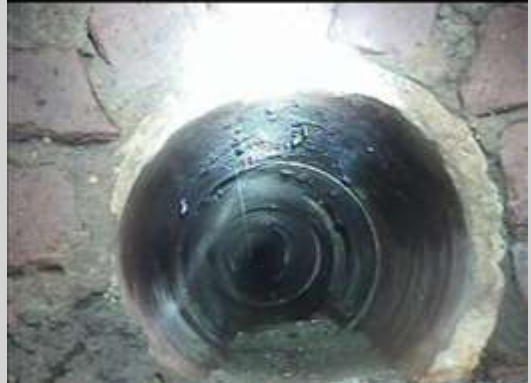
12 O'Clock Outflow

8 in. Circular Gravity Sewer
Pipe Out @ 12 O'Clock

Deposits: ☐ None ☐ Mud ☐ Sludge ☒ **Debris** ☐ Grease

Silt Depth: **0.25** (in.) Deposits Extent: **Light**

Infiltration: **None** Pipe Seal Cond: **Cracked**
